Relationship of Surrounding Geology to Well Recovery Properties for Selected Cedarville University Water Supply Wells

By Kaitlyn Sturm, Geoscience Major, Cedarville University

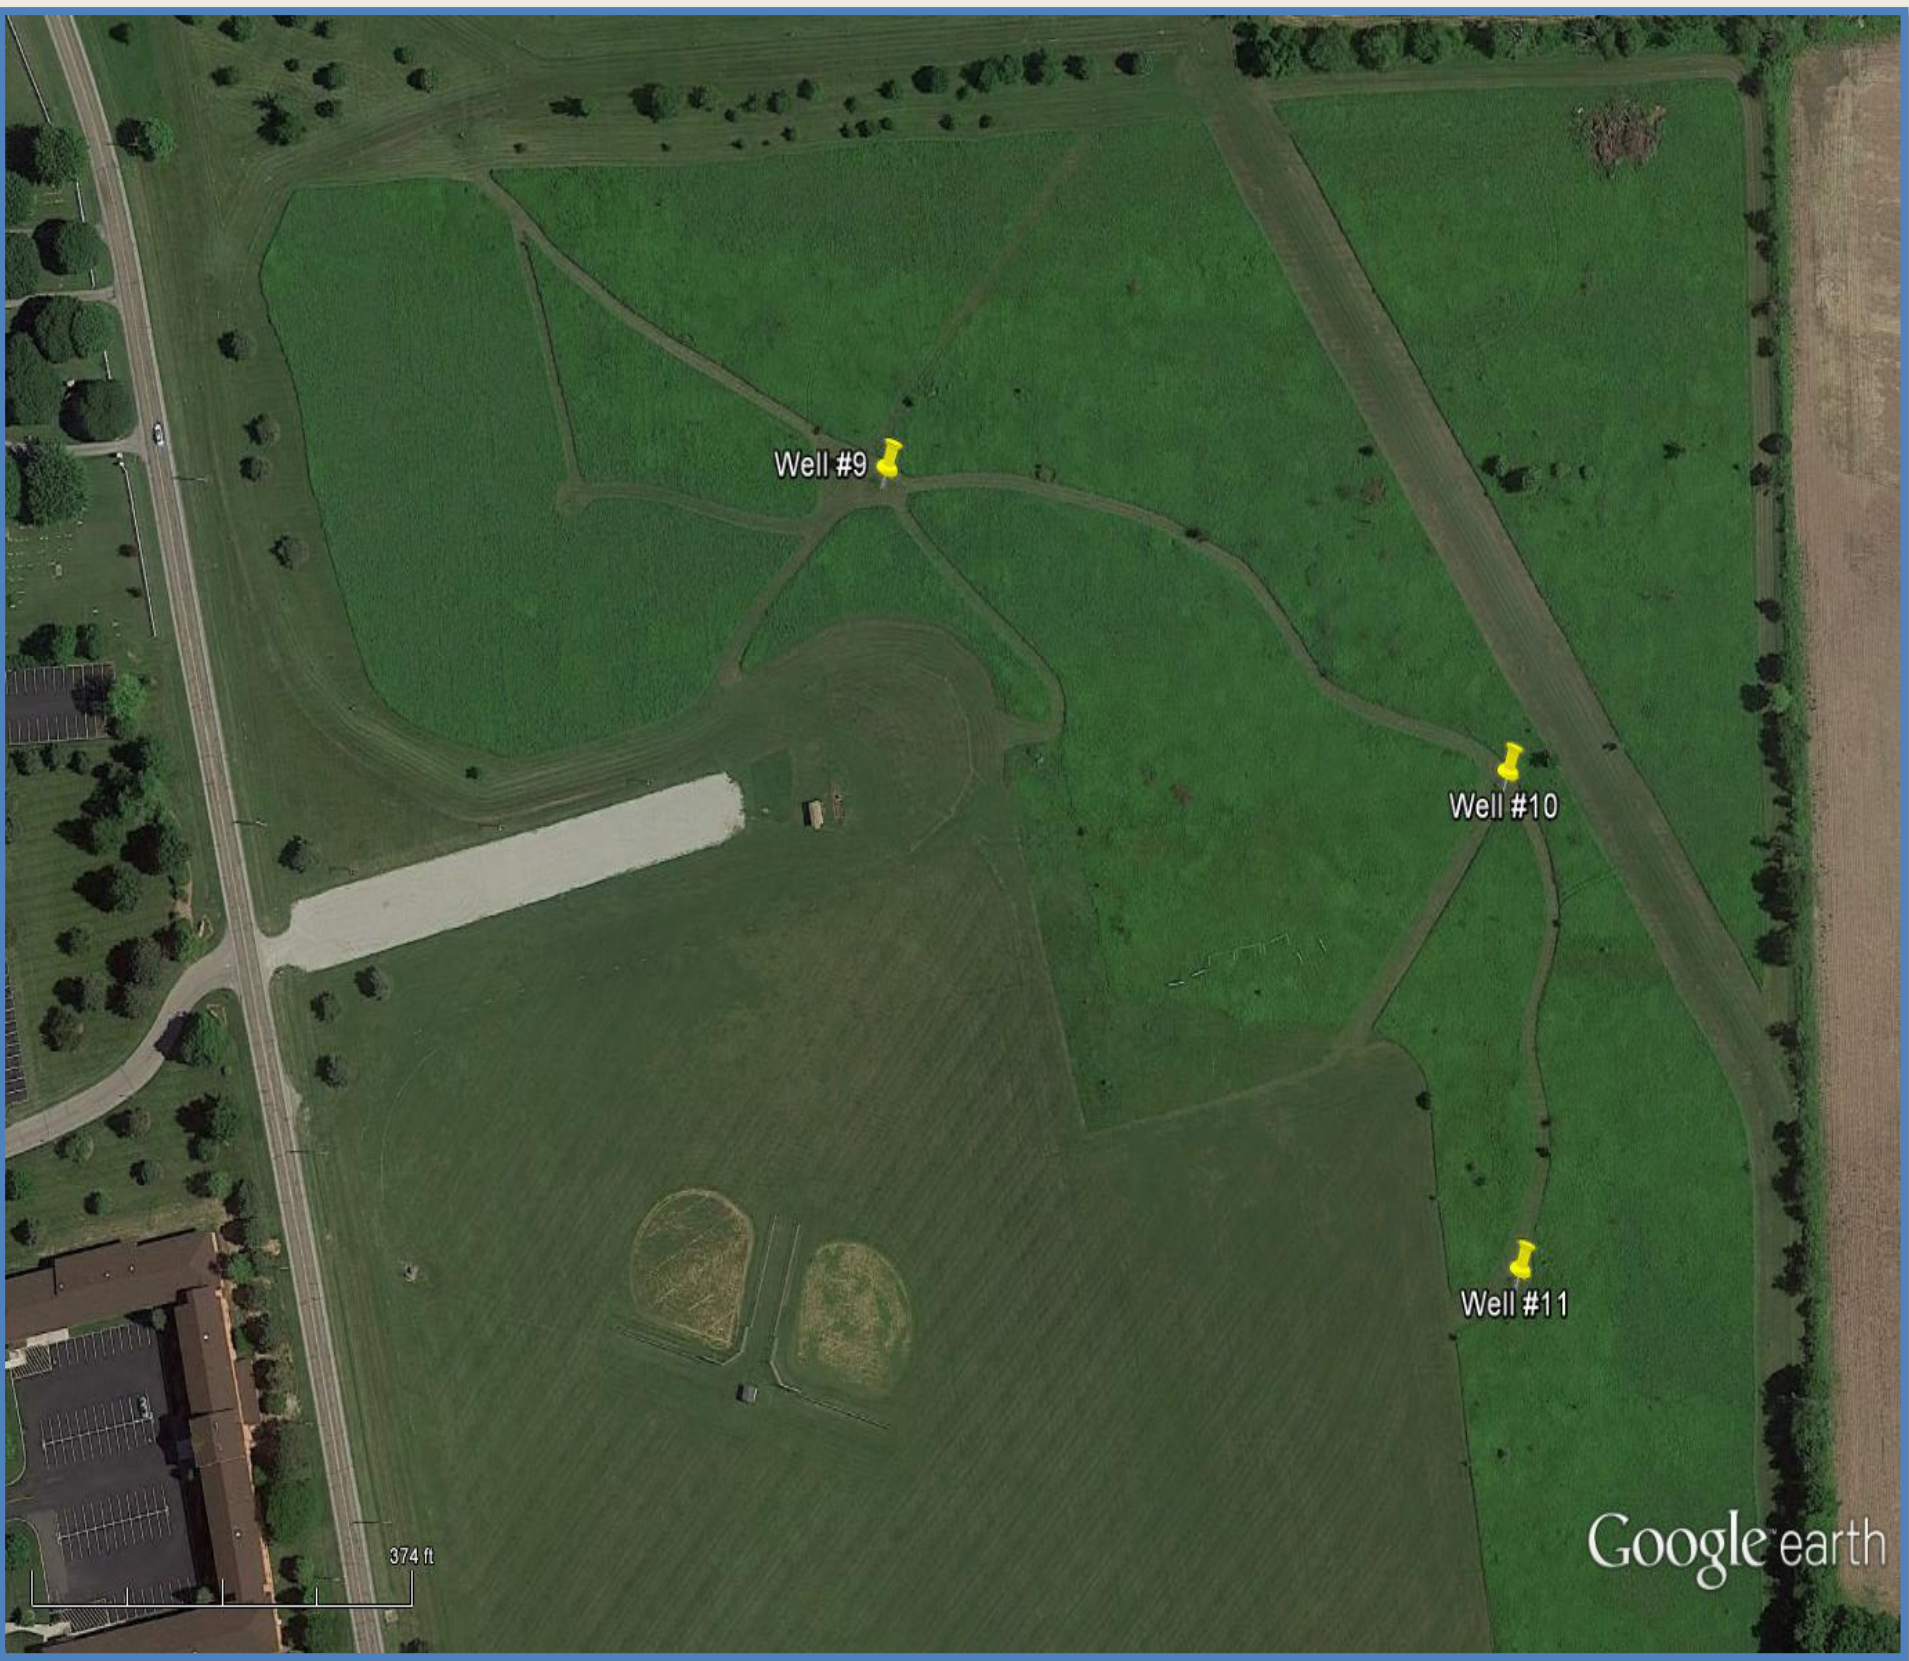
According to the drillers log for well 10, the upper limestone/dolomite extends to a depth of 121 feet. While, the Lockport limestone/dolomite extends to a depth of 110feet. The shale is present from 121 feet to 130 feet; the Brassfield was encountered at this point. The lower limestone unit extends to a depth of 180 feet, where the shale is encountered. The original pumping test was conducted on September 14, 1994. The static water level noted before the test was 12 feet below the top of the casing.

Well #10’s lithologies:

- Yellow Clay 0-5ft
- Yellow Clay 5-9ft
- Muddy Sand and Gravel 9-12ft
- White Limestone 12-26ft
- Gray Limestone 26-95ft
- Gray Limestone and Shale 95-121ft
- Gray Soft Shale 121-130ft
- Pink Limestone 130-143ft
- Limestone DRG 143-161ft
- Hard Gray Limestone 161-180ft
- Shale 180-190ft

According to the collected data from the well recovery test, the rate of recovery is related to the amount of glacial drift, or depth to bedrock. The cascading water was encountered at 28ft.

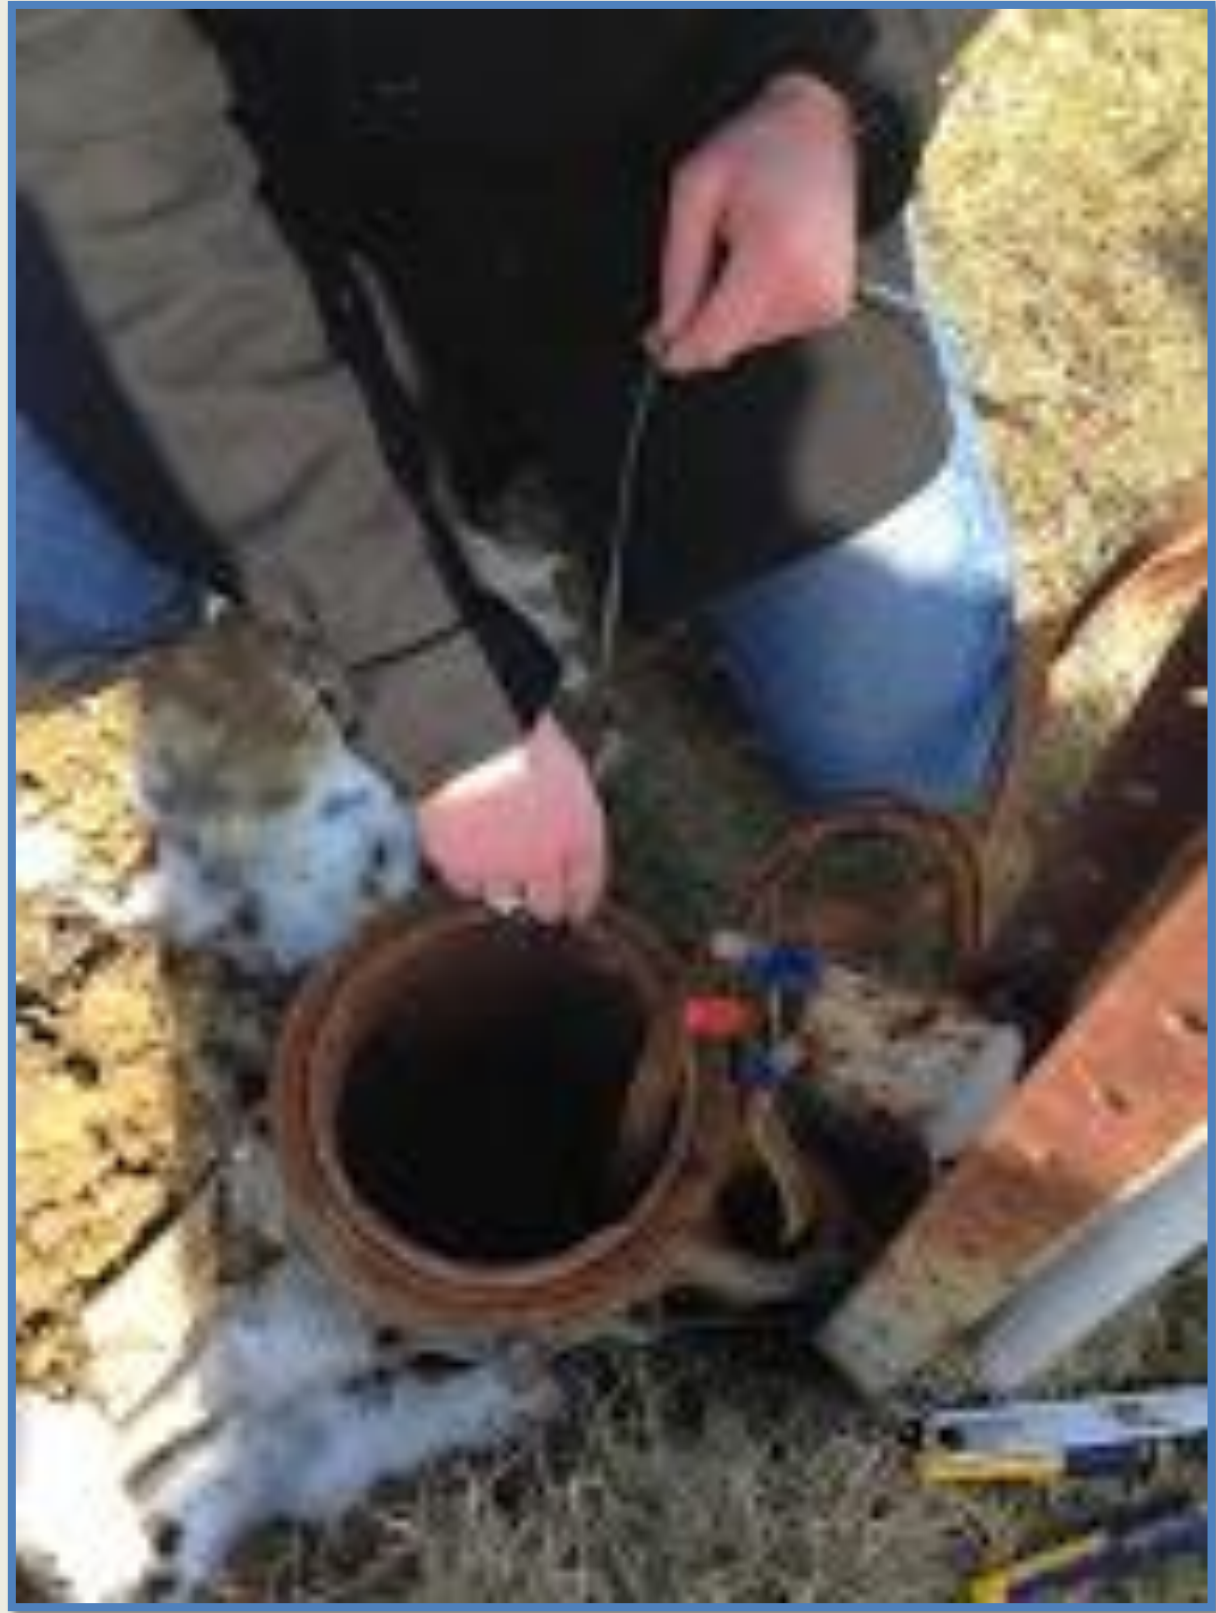
According to the drillers log for well 11 the Lockport limestone/dolomite was present from 11 ½ feet to 121 feet. The shale extended to a depth of 130 feet at that point the Brassfield was penetrated. The Brassfield was present from 130 feet to 180 feet. The well was terminated at 190 feet after drilling into the lower shale unit. During the initial pumping test, the pump was placed in Well #11 and a 24 hour test was started on Oct 19 1994. The static water level noted before the test was 17 feet below the casing. The pumping level stabilized at about 170 feet.

Well #11’s lithologies:

- Yellow Clay 0-9ft
- Sand and Gravel 9-12ft
- Limestone 12-27ft
- Limestone 27-95ft
- Limestone with shale 95-118ft
- Shale 118-130ft
- Limestone 130-180ft
- Shale 180-190ft

According to the collected data from the well recovery test, the rate of recovery is related to the amount of glacial drift, or depth to bedrock. Cascading water was encountered when the water level meter was below the casing.
